Article

Evaluating the Infiltration Performance of Eight Dutch Permeable Pavements Using a New Full-Scale Infiltration Testing Method

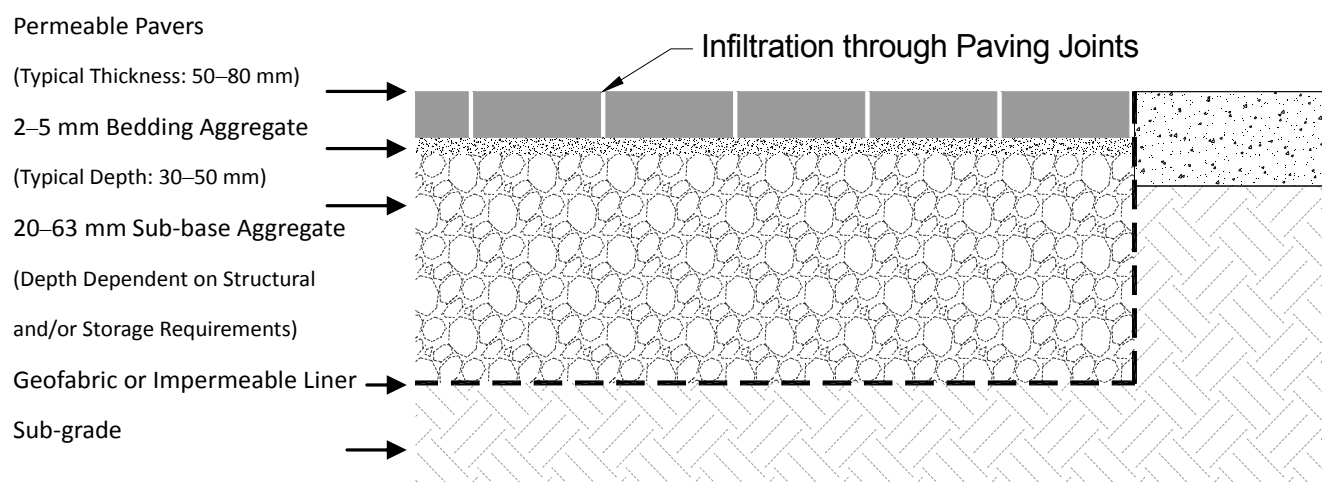
Figure 1. Typical permeable pavement structure.

- Construction: While the construction of the test pavements were generally similar to that shown in Figure 1, there were slight differences between the sites. These included the size of the paving joints, different types of bedding aggregates and different pavement laying processes.

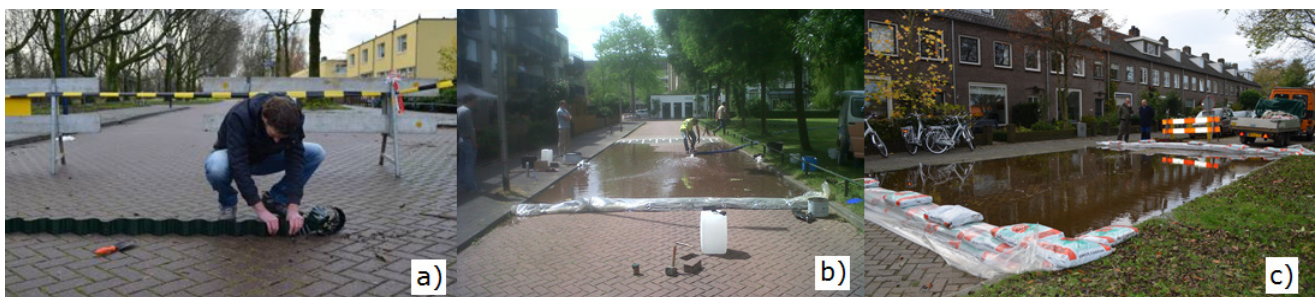
To accurately define the infiltration testing area and to contain the water used to infiltrate the pavement, it was necessary to construct small, temporary dams at the ends of the pavement test sections. The roadway kerb and gutter system retained the water on the sides of the pavement test sections. A number of dam variations were trialled at the eight different test locations (Figure 4). These included:

Figure 4. Various dam variations used at the different test locations; (a) impermeable barriers; (b) plastic wrapped soil core; (c) soil-filled plastic bags.

Where possible, one of the preferred methods of containing the water within the test site is to choose a section with an existing raised traffic calming device (speed hump) at one (or both) ends. This saves considerable setting-up time and also minimises leakage problems during testing. It is also advisable to select the section of pavement with the least number of existing drainage gullies within the pavement surface or gutter. Drainage gullies need to be properly sealed to prevent water from

leaking from the test area and entering the underground stormwater drainage system. This can be both difficult to accomplish and time consuming. Of all the methods trialled to create temporary dams, the soil-filled were found to be the most effective. This was due to their ability to properly seal the test sections, the rapid filling and emptying characteristics of the bags, the ability to reuse the material and the ease of construction by hand without the need for heavy machinery.

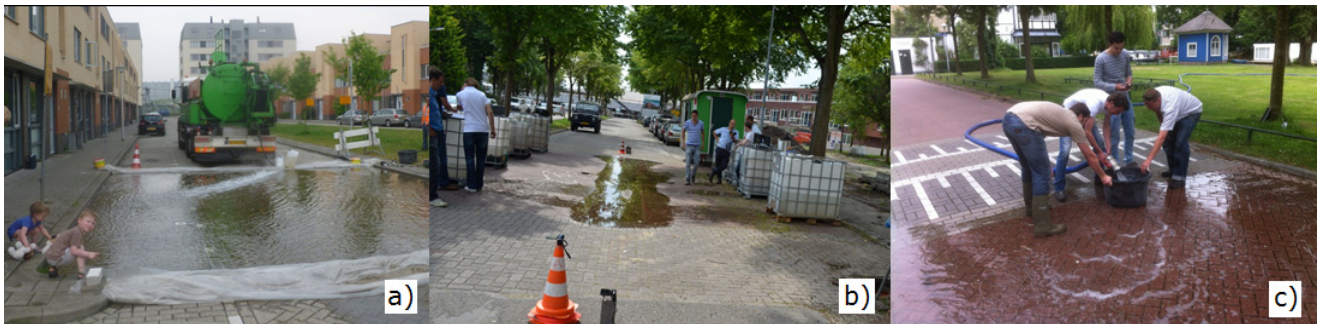
The new infiltration test requires large volumes of water to be discharged onto the test paving section in order to inundate the pavement surface. Depending on the site location, a number of different water supply options were trialled in this study, including transporting water directly to the site with water trucks (Figure 5a) or water tanks (Figure 5b) and pumping water directly from nearby canals (Figure 5c).

Figure 5. (a) Water truck supply; (b) water tank supply; (c) pumping from canal.

Of the three water supply methods trialled, it was found that pumping the water from a nearby canal was the easiest option, where this option was available. This method offered total flexibility with types of testing and also offered an unlimited availability of water. It is recommended to include a flowmeter in the water supply line to allow accurate monitoring of water inflow rates. Water trucks were the second easiest option. However, these had the disadvantages of being expensive and difficult to arrange, manoeuvre and park, and they generally had only limited water supply capacity. When a water truck must be used, it is advisable to ensure that the outlet is fitted with a flowmeter to measure flow rate into the test pavement area.

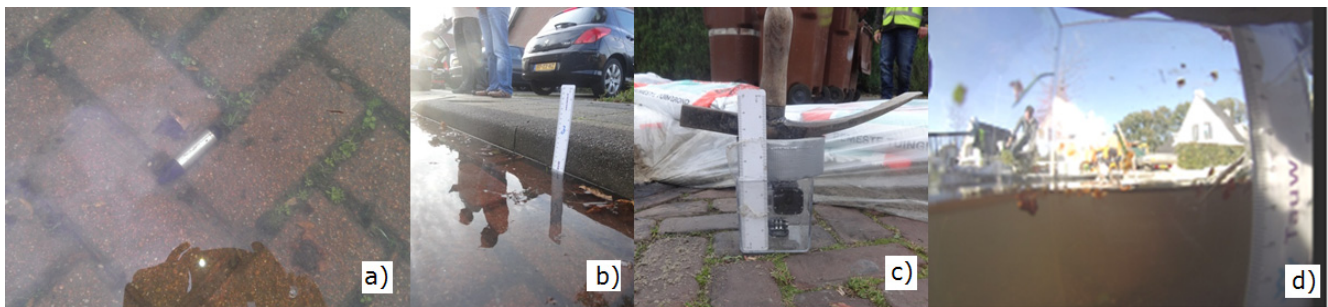
Three different measurement methods (Figure 6) were used in conjunction with the pressure transducers in order to calibrate and verify the transducer readings. The three methods were:

Figure 6. (a) Minidiver installed at lowest point of pavement; (b) hand measurement point; (c) underwater camera set-up; (d) underwater camera view.

Water level measurements were taken using a simple 300-mm hand ruler (Figure 6b) at strategic locations on the pavement surface throughout the duration of the testing. These measurements were used to verify the functionality and accuracy of the self-logging pressure transducers, as described above. Photographs of each hand measurement were also taken for documentation and verification purposes.

A high-definition video camera was also used at a number of strategic locations to record the decrease in pavement water levels over the duration of the tests. The camera was placed inside a waterproof, calibrated, transparent box, so that it could capture the entire infiltration process (Figure 6c). This system allowed real-time monitoring of the entire infiltration process and also facilitated precise verification of the pressure transducer measurements.

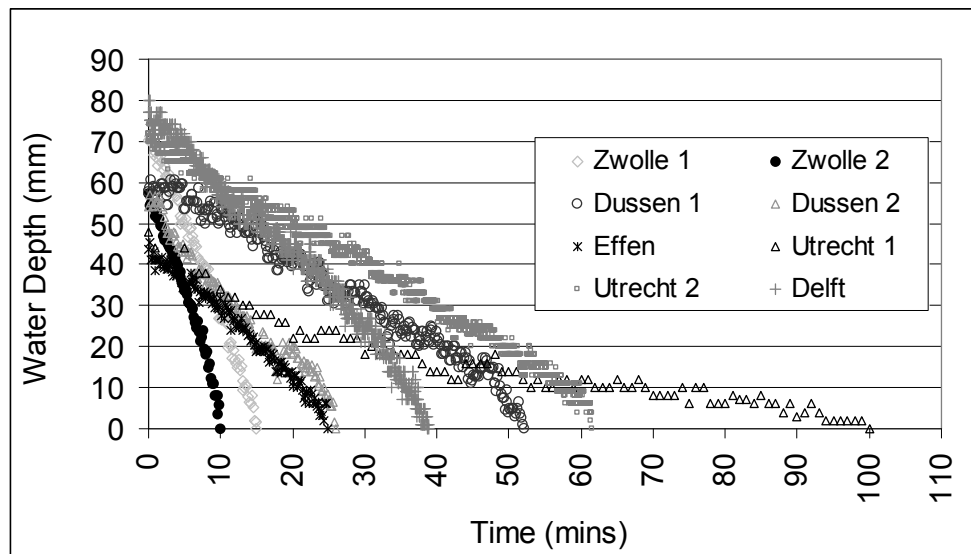
Figure 7. Infiltration curve results for the eight permeable pavements tested in the study.

The surface infiltration rates recorded for each of eight test pavements using the new experimental test procedure are shown in Figure 7.

All eight test pavements (Table 1) were sealed, inundated and monitored as described above. The pressure transducer readings were then plotted against time to generate precise infiltration curves for each of the test sites (Figure 7). Simple linear regression analysis was used to generate lines of best fit for the transducer readings from each site. The equations of the linear regression lines were then used to calculate the average infiltration rate in mm/h for each test site (Table 1).
